Seneca College - King Campus

Heritage Report

PHILIP GOLDSMITH | ARCHITECT

20 January 2012

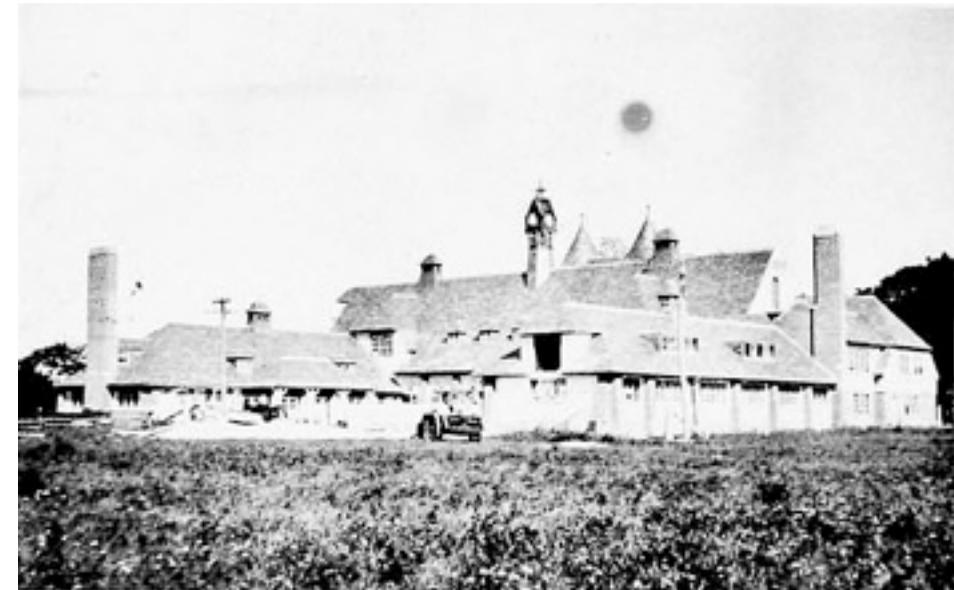
8. Eaton dairy farm complex c 1924, Note, a fire destroyed the large barns in the 1969, the foreground buildings still exist.

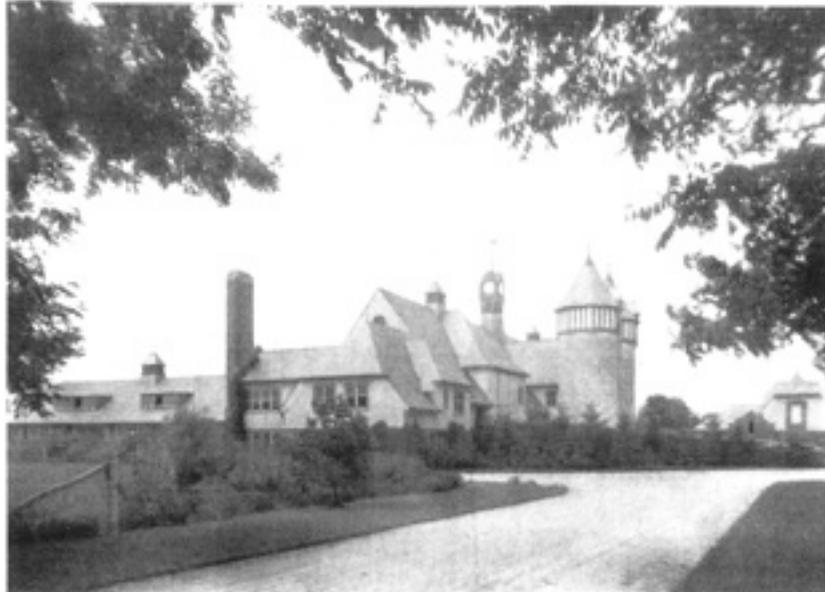
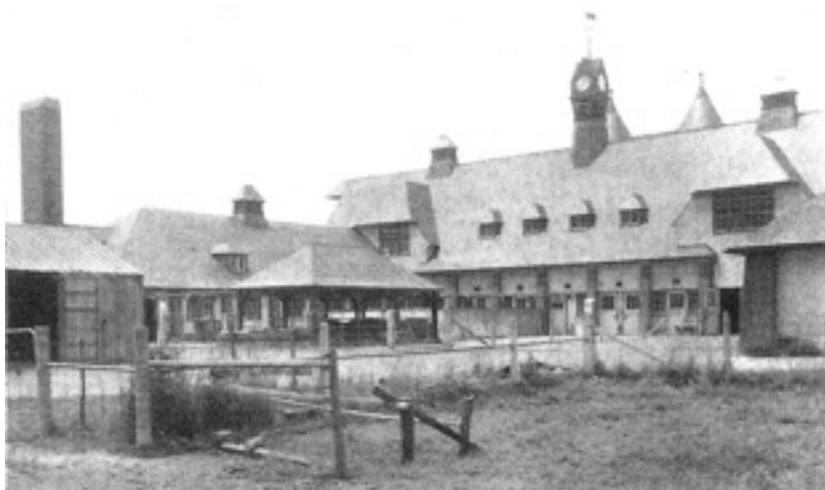
9. Views of the Farm Complex March 1930, Top view from west, bottom farmyard from east. House and Garden

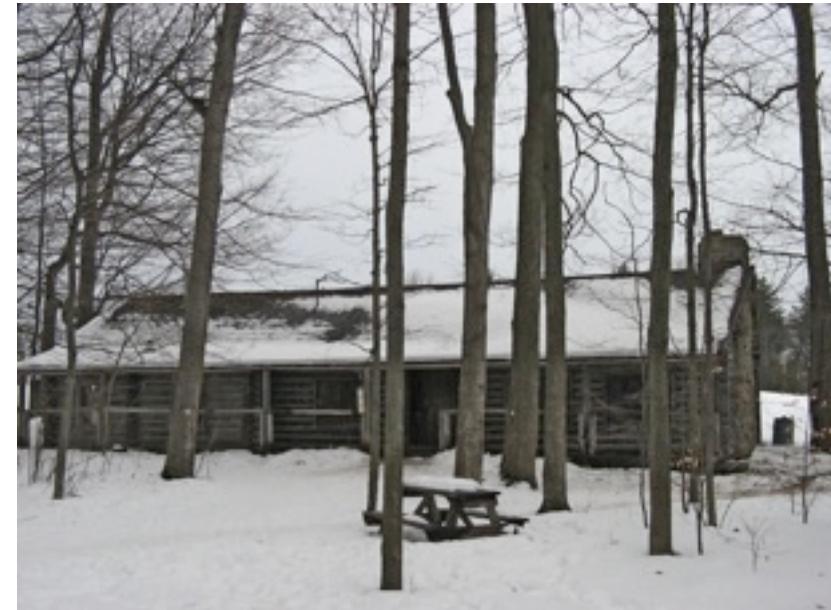
13. Log Cabin c 1974, a result of an early programme in log building construction

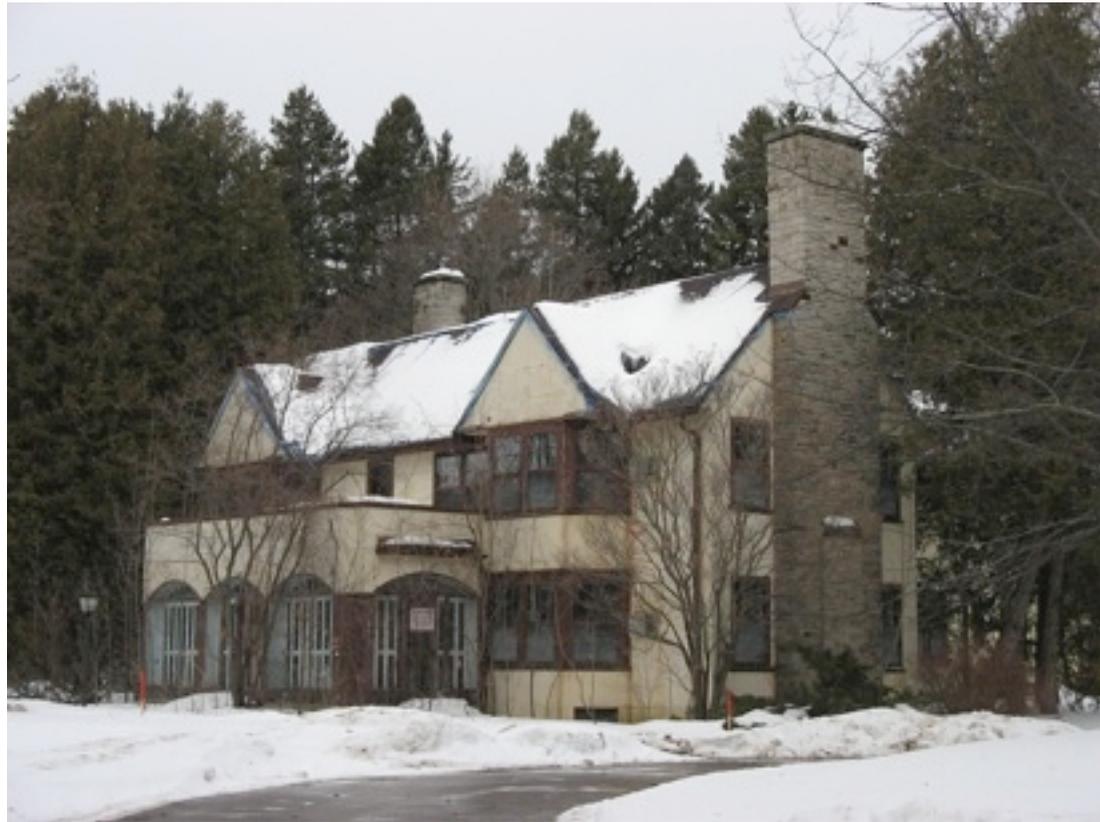
16. Villa Fiori - current

Sadly deteriorated the Villa was constructed c 1920-22. It was here that Lady Eaton stayed during WW2 as the Hall was in use by the Navy.

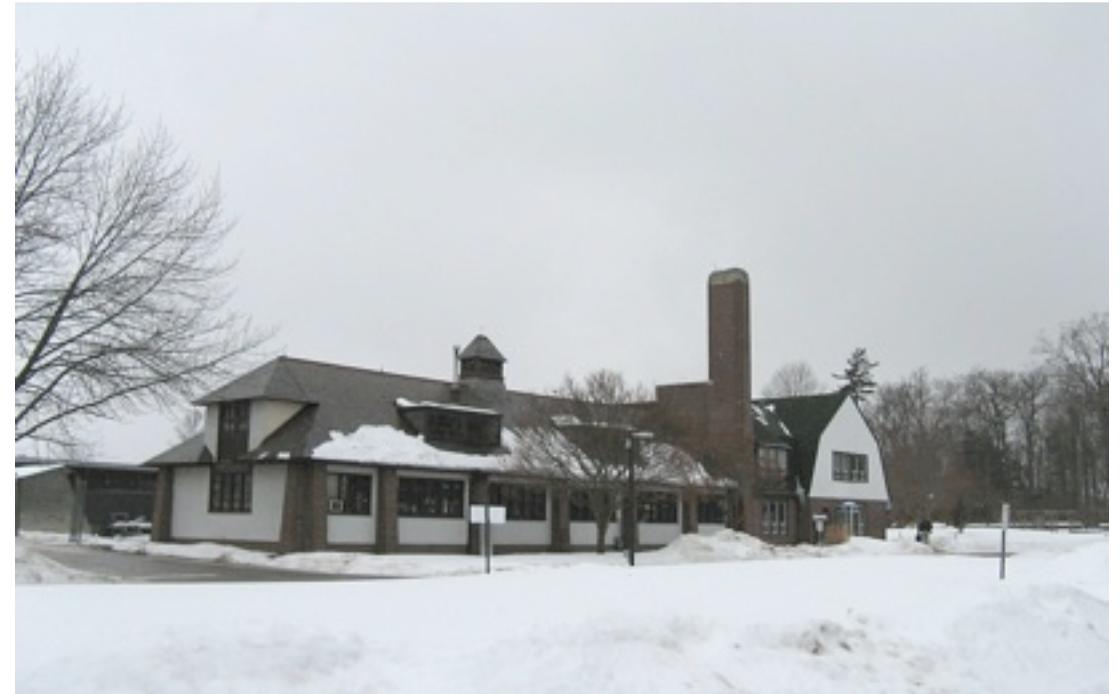
17. The Eaton Dairy Barns

See image above for original scope. The large barns burned in 1969 however these building survived.

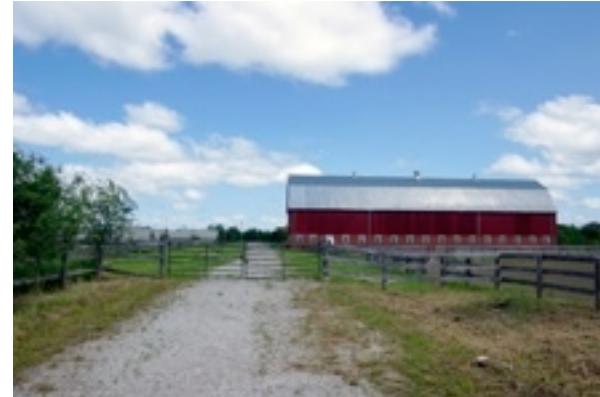
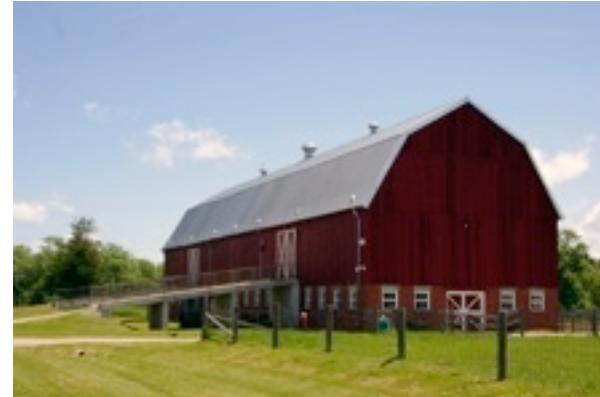
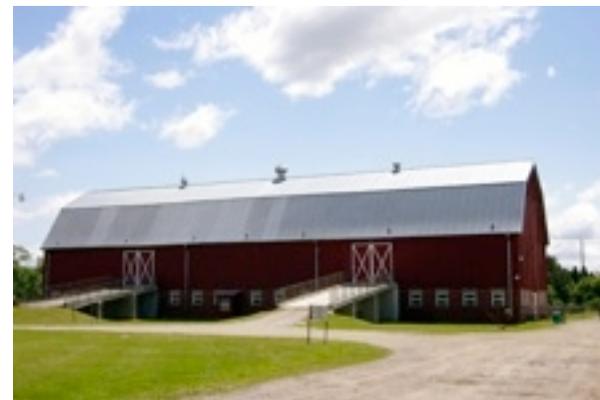
This is really a show barn, built to a standard well above a normal working farm. It is constructed in a gambrel form with the upper shape reflecting the trusses which create both wall and roof. The upper structure is wood and this is constructed atop a concrete foundation. The stables are at the ground level and the hay mow is at the second floor. There is no longer any sign of a granary at the second floor. The second floor is accessed via two large concrete ramps of recent construction

.1, .2, .3 The horse barn was constructed in the 1920s to serve the Eaton’s interests in the “Hunt”.

It is a dominant building at the south end of the Seneca lands.

We recommend any alterations be contained within the structure or as small carefully placed additions which do not dominate the site or alter the general form.

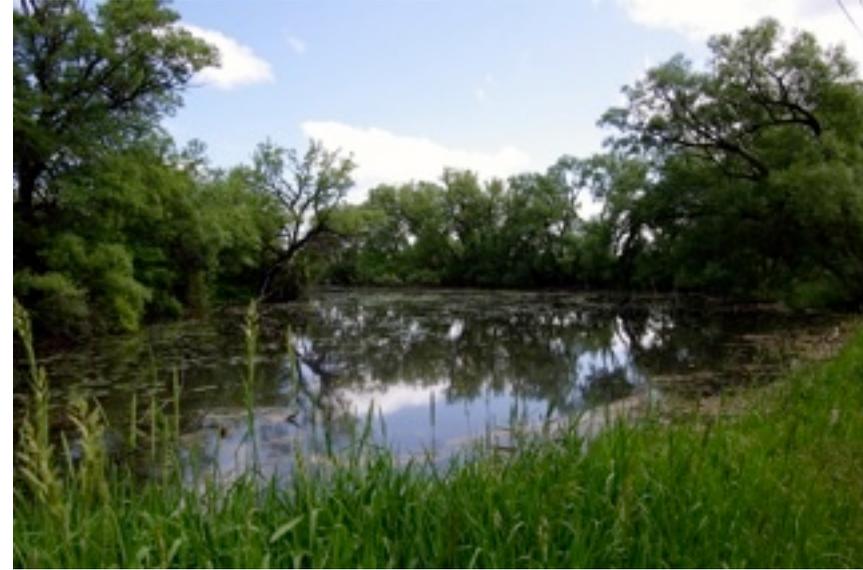
.4 View of south end pond on Seneca Lands. This pond is the remains of a larger mill pond that extended north from the saw mill dam. The 1878 Atlas shows this extending up to the lake. It is an important heritage landscape feature.

We recommend any alterations to this landscape from the road to the lake take into account the Cultural Attributes of this former mill pond and watercourse. New buildings or landscape changes should be held back from this area. Any work in this valley should aid in the interpretation of the history of the site.

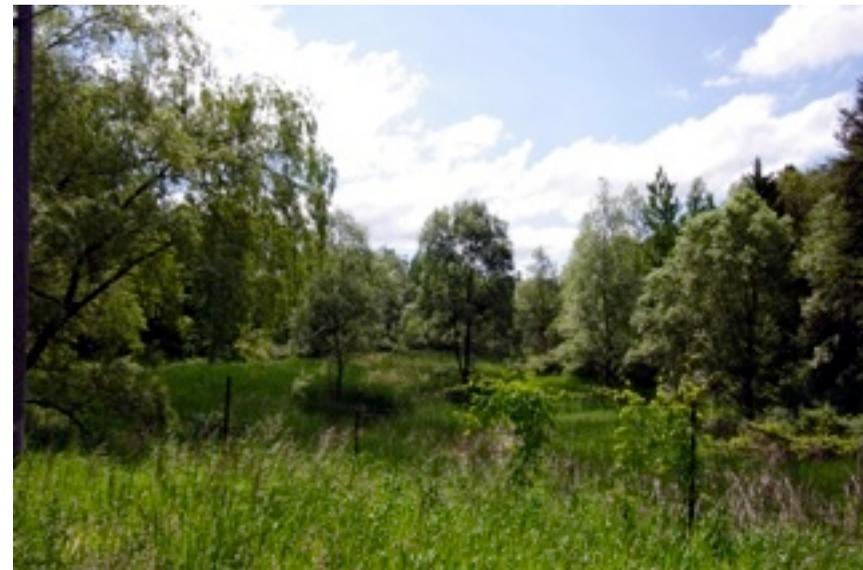
.5 View of the depression south of SR 15 which was once the mill pond for the Ferguson Saw Mill. The Mill was located at the far end of this view.

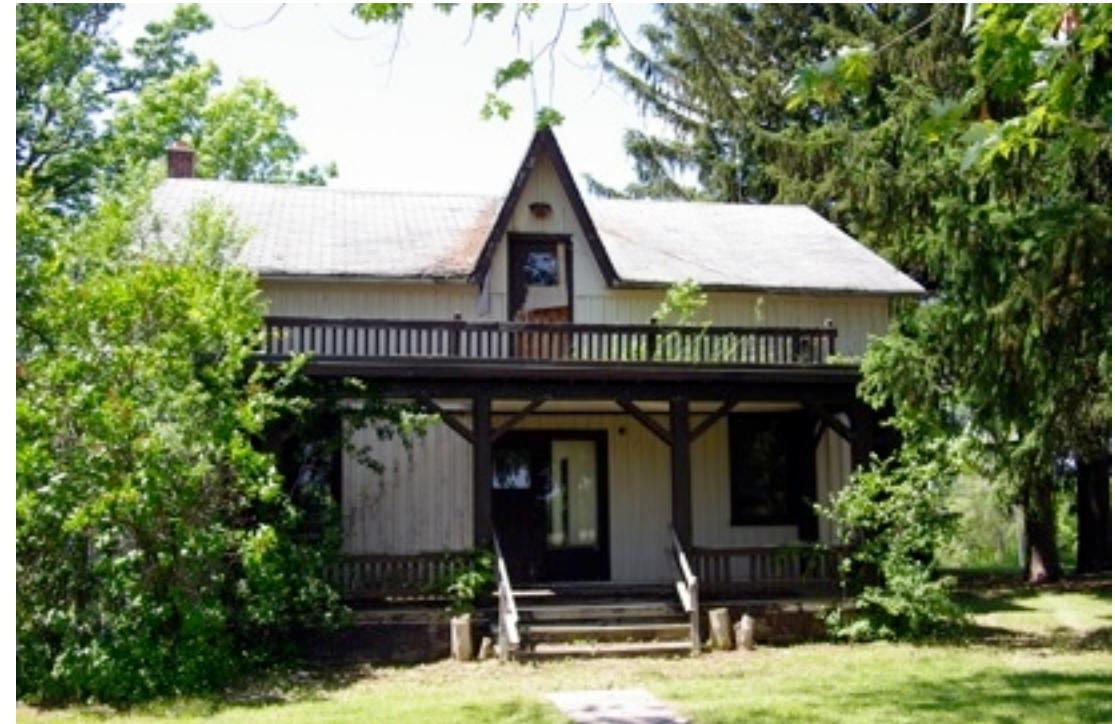
1. form and height of the building including roof slopes, end gables, centre dormer and chimneys (some chimneys may be missing)
2. three bay design with a central doorway under the dormer
3. A full front covered porch (the current one does not appear original)
4. doors and windows (the current ones are not original and out of character)
5. three elevations front and sides both design and historic materials

.6 The Ferguson House c.1850s. This is a view of the front, east elevation, and shows that the form and most of the original design is intact. Some or all of the porch may have been altered and the windows and doorway have been replaced in the original openings.

Any work planned for the building or alterations for other uses should respect the Ontario Vernacular Style heritage attributes and as much as possible, both retain original design elements and replicate or restore them where currently altered on the prime elevations. The interior could be altered to serve a viable use.

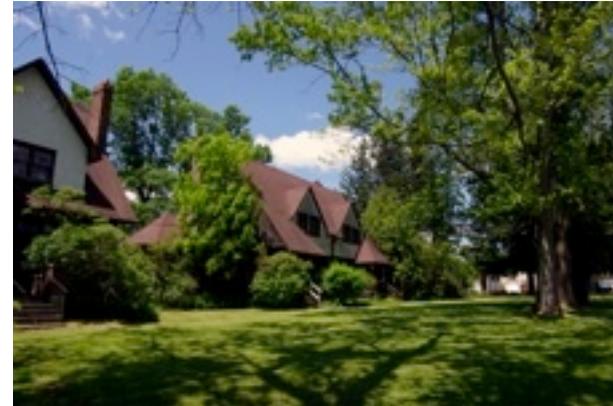
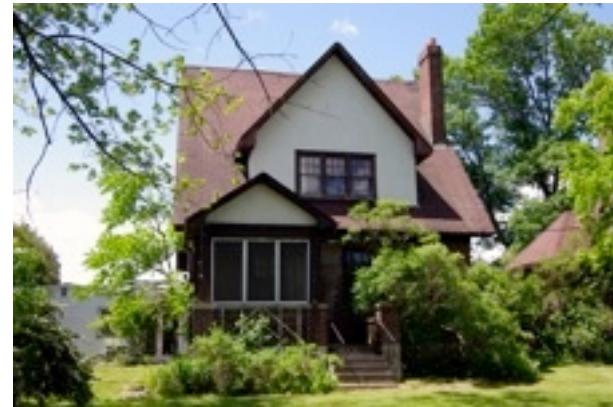
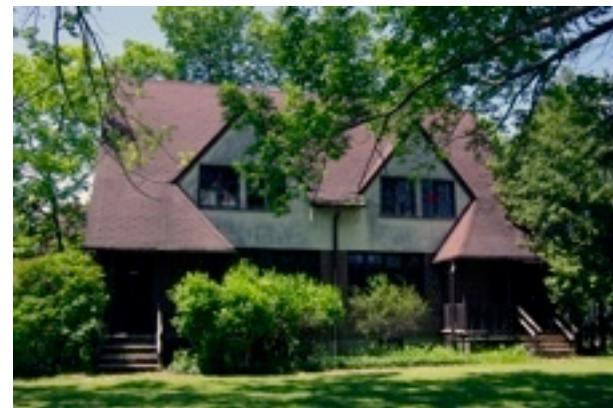
The houses were designed in an English Arts and Crafts style which draws inspiration from the Tudor period in forms and details. They appear to be of substantial construction and in good condition needing typical maintenance.

.7, .8, .9 Images of the Eaton Dairy Farm, farmhouses. These attractive and picturesque Arts and Crafts Cottages were constructed at the time of the development of the farm operation.

Any work planned for the buildings, or alterations for other uses, should respect the Arts and Crafts Style, heritage attributes and as much as possible retain original design elements on the prime elevations. alterations on or to the rear of the building would be recommended.

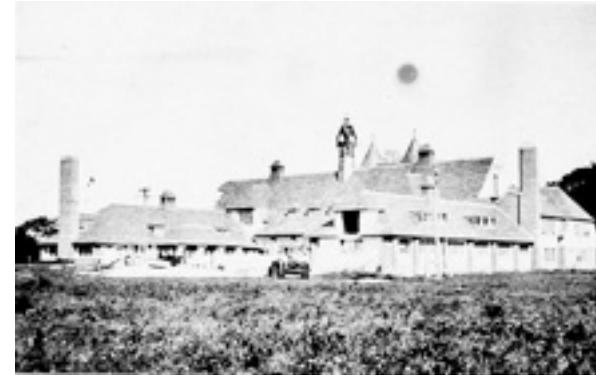
.10 Historic Image of the Eaton’s dairy farm complex c. 1920s. The buildings at the right front can survive a devastating fire that took the main barn in the 1960s. See below.

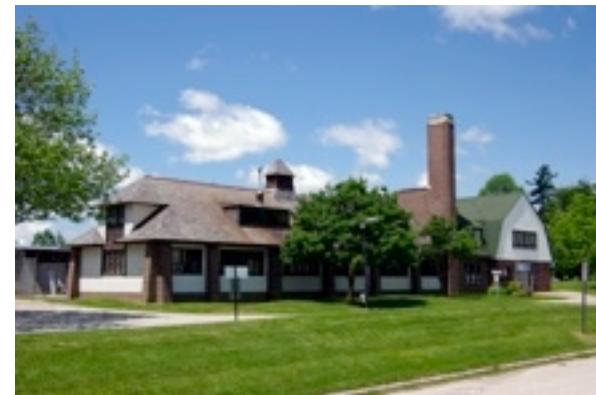
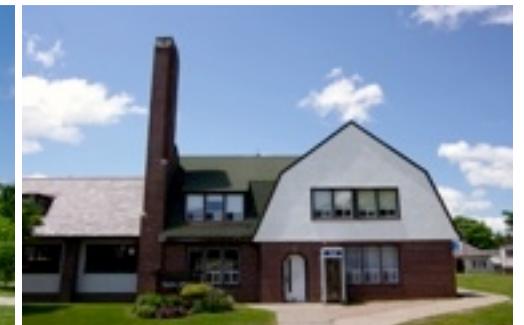
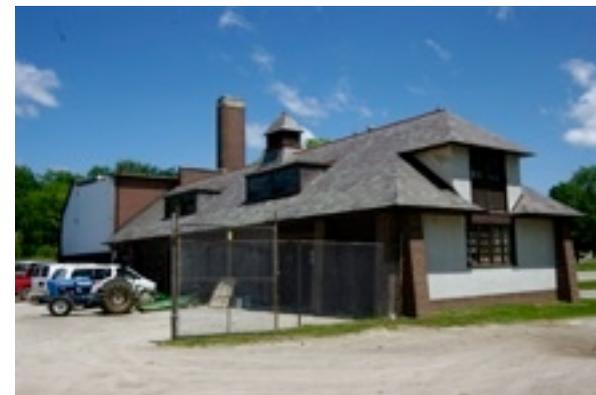
As one of several structures associated with the Eaton farm it is an important heritage building. The design of the building is in an Arts and Crafts style of the period consistent with all the period work of the farm. It appears to be in good condition. A change to the original roof line from a simple slope to a gambrel roof is evident in the “head” building.

.11, .12, .13 Front wing of the dairy farm. The original use of this wing needs to be confirmed but it would appear to be cattle stalls to the left and a head “office” building to the right. Note that the roof line is altered from the 1920 appearance. this may reflect repairs after the less serious fire in 1937.

Any work planned for the building, or alterations for other uses, should respect the Arts and Crafts Style, heritage attributes, and as much as possible retain original design elements on the prime elevations. Alterations on or to the rear of the building would be recommended. As the original barn was destroyed, the middle of the site is open and may be a good location for a new building of a similar large scale which could knit together the surviving heritage elements into an interesting “new” complex of contemporary new - old mix.

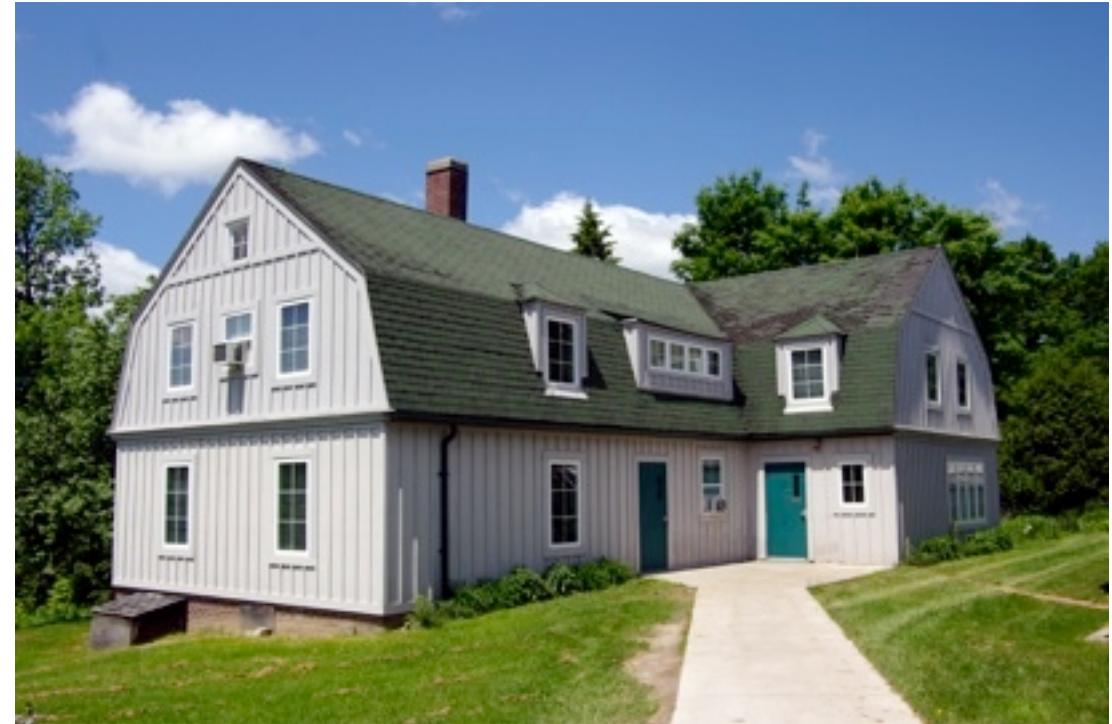
.14 The original purpose of this charming building is unclear. It appears to be part of the farm complex and to have been constructed in the 1920s or 30s. Additional research may reveal its purpose. The gambrel roof matches the newer roof of the front wing which suggests it may have been constructed in the 1937 period after the fire.

Any work planned for the building, or alterations for other uses, should respect the its period "barn" like style, gambrel roof, domestic form, heritage attributes and as much as possible retain original design elements on the prime elevations. alterations on or to the rear of the building would be recommended.

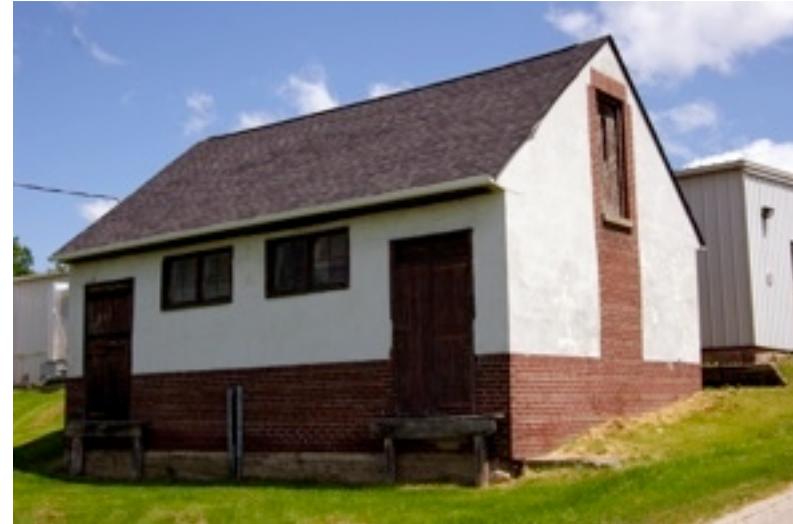
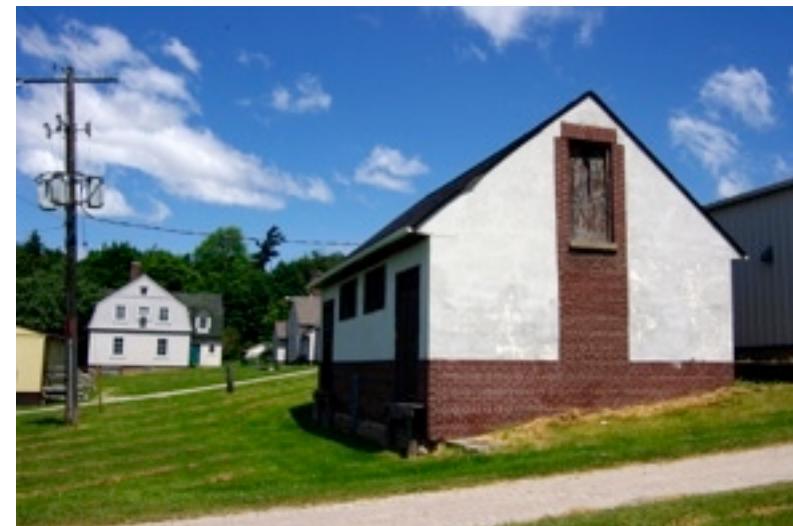
.15, .16 The design of this small building is consistent with the original design of the farm complex in the 1920s. Refer to image .10 and .11. From its design we assume it was a small dairy or creamery.

This element is of heritage significance and should be preserved as a portion of any new development on site.

We recommend this small building be treated as a pavilion in a landscape. It is too small to withstand any significant alteration or major addition without losing its historic qualities. If linkages are required they should be small one storey and of a breezeway nature.

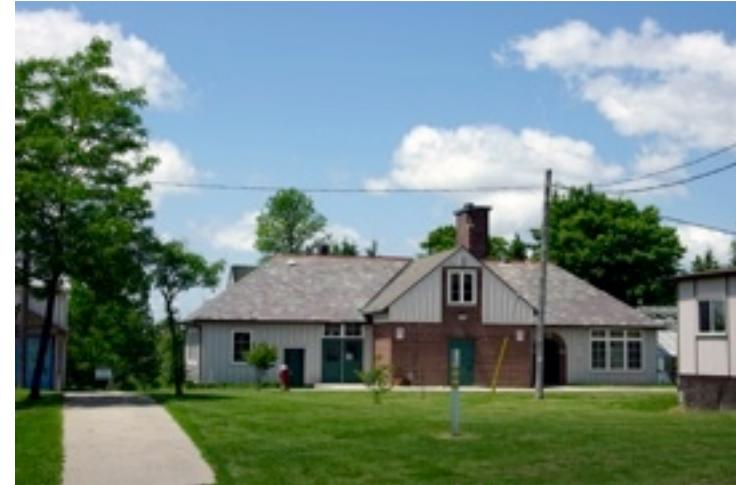
.17, .18 Lady Flora Eaton in her memoirs refers to a green house complex on site which supplied cut flowers to the Eaton's Toronto store. This greenhouse is almost certainly the same building and a survivor from the 1920s. Note, the head building is of the same design as the dairy farm buildings.

This is very specifically a greenhouse complex and attempts should be made to retain this function specific to the building. Should other uses occupy the building the greenhouses should be retained at a large scale, perhaps not all of it, but sufficient to preserve the heritage attributes. Any addition should link to the rear of the head building or to the green houses in a deferential manner. The primary elevations, form, design and materials of the buildings should be preserved or restored.

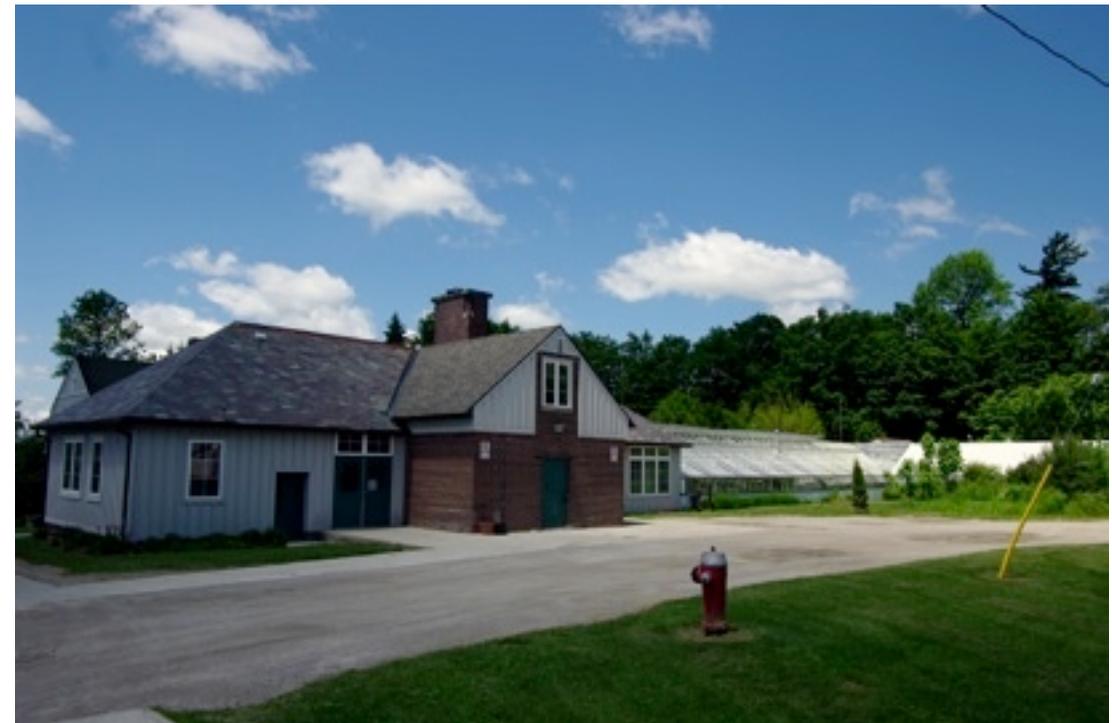
The building appears to be complete and in good condition however some material replacement including windows appears to have taken place.

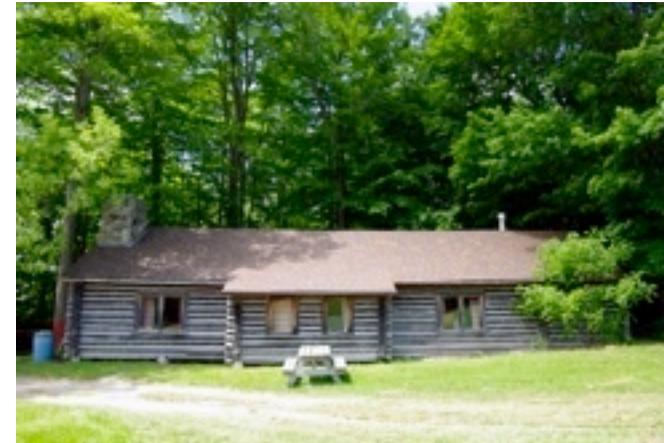
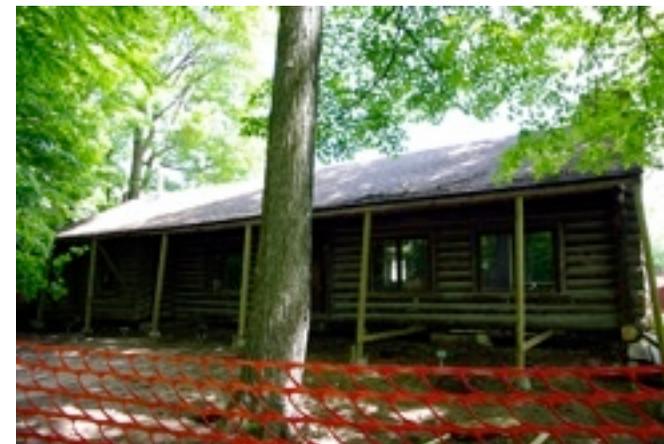
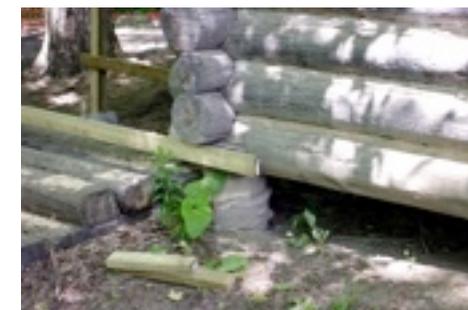
The building is not of a particular "heritage" design except for the actual log construction. It appears to be generally in good condition with some exception where logs near grade show some deterioration and the porch floor structure has rotted and is currently being replaced. We consider this building worthy of preservation and its significance rests in the storey of the founding of the Seneca King Campus and the spirit of the time.

19, .20, .21 This log building was constructed shortly after Seneca College took possession of the Eaton Estate. It was the result of a programme that studied early Canadian buildings.

Note the building rests on concrete piers seen in image .21.

although in generally good condition the porch floor structure had rotted and was being reconstructed at the time of the photograph.

Other than retaining the exterior log construction and basic exposed form of the building we feel other alterations either of the interior or an addition to the north of the building would be acceptable. However, our recommendation would be to retain as much as possible as we feel the building will be considered of increasing heritage interest as the years pass.

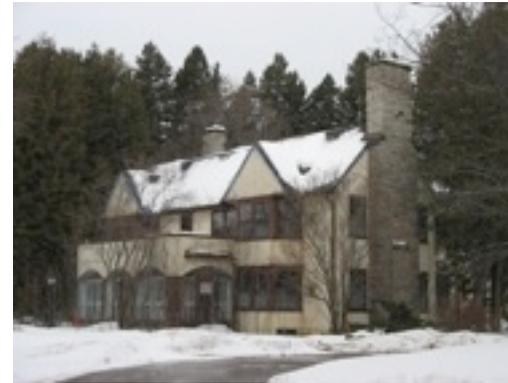
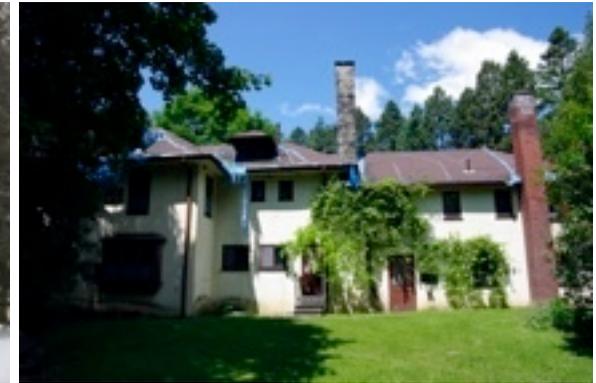
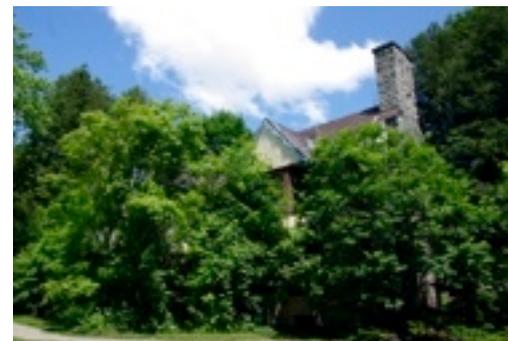
Early in the history of Seneca's occupation, the house was used for arts programming and later as a management training centre. It has however, fallen on hard times. The Villa is in a sadly deteriorating condition. We consider the building to be of primary heritage importance an element of the early history of the Eaton years on the site. We recommend that stabilization work be done to save the building and that a use be found for the building and site relevant to Seneca in order that it continue, or again, serve a useful purpose. At the very least perhaps it could be considered as a residence for either senior students or staff.

.22, .23 (above), .24 (left) Views of Villa Fiori. This attractive Arts and Crafts home was constructed in the 1920s development of the property, prior to the Eatons deciding to sell Ardwold in Toronto and permanently moving to the site. Lady Eaton stayed in the house during WW2 when the Hall was a recuperation hospital. Although used initially by Seneca for arts and later management study programmes, it is now abandoned and in deteriorating condition.

Any work planned for the building, or alterations for other uses, should respect the Arts and Crafts Style, heritage attributes and as much as possible retain original design elements on the prime elevations. Alterations on or to the rear of the building would be recommended and the interior could be altered for new uses.

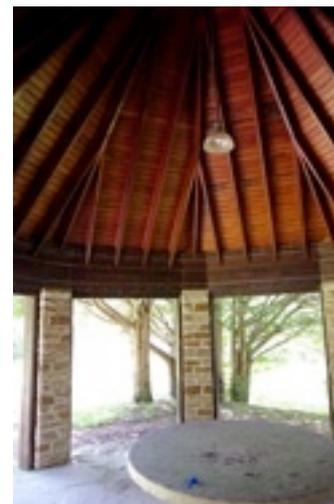
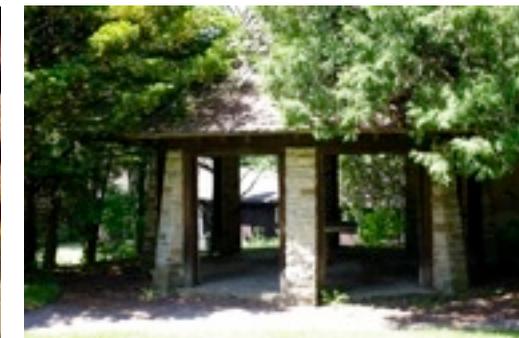
.25, .26 Views of the garden pavilion associated with Villa Fiori which was designed and installed in the 1920's during the Eaton occupation of the house.

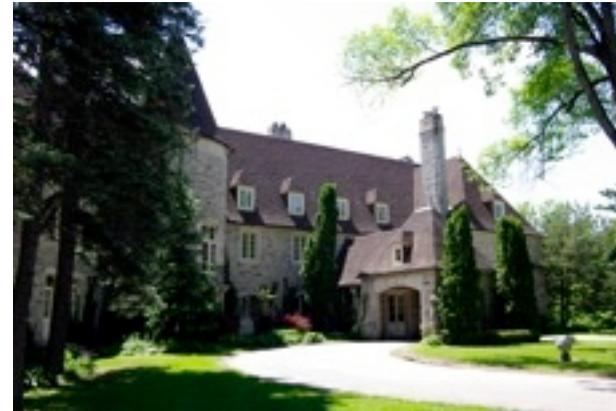
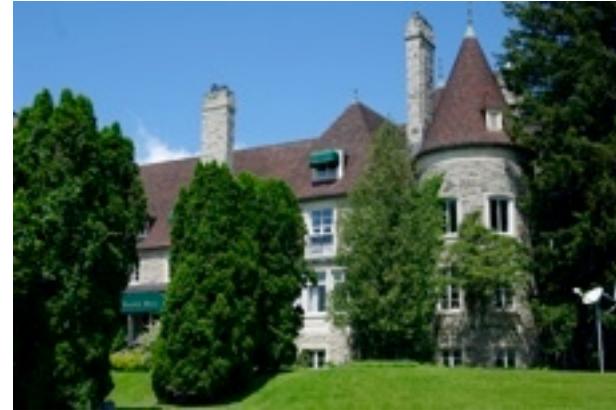
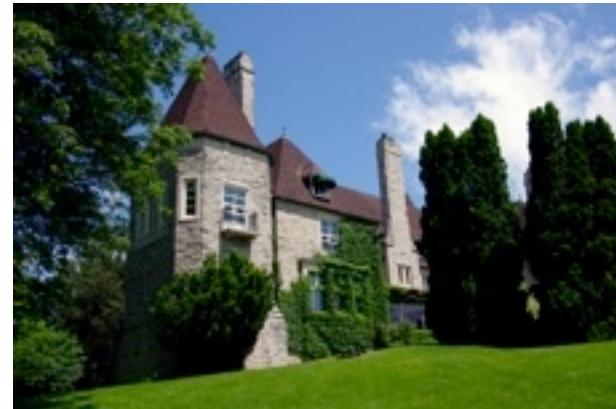
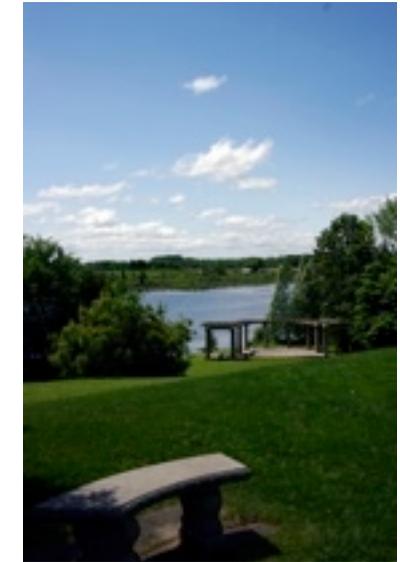
.27, .28, .29 (left), and .30 (above)

The significance of the house is primarily found in its history and association with one of Canada’s premier and best known families, the Eatons. The grandeur of the design is a reflection of the success of the Eaton retail operation and the position the family enjoyed in society. The Hall is a well executed and carefully constructed work utilizing fine materials to designs by a well respected firm of Architects, Allward and Gouinlock.

Views of Eaton Hall; the entrance court, south east corner and south west corner overlooking the great lawn. .30 is a view from the terrace to the lake.

This grand house is one of a very few ever constructed to this level and is worthy of preservation over almost all of the exterior and throughout much of the interior. Alterations to date have been somewhat modest and in keeping with the original scale and design.

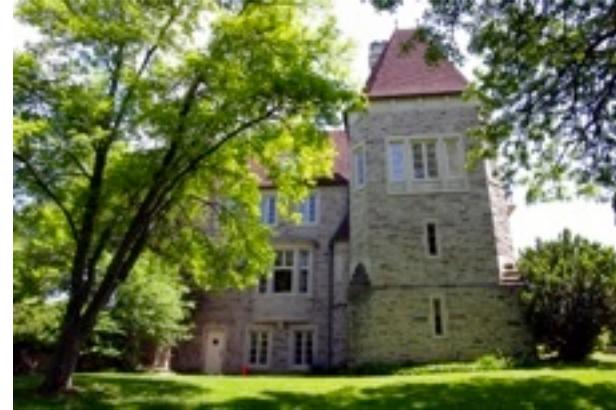
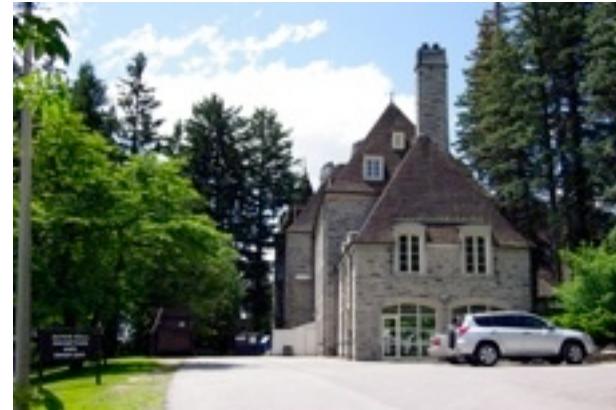
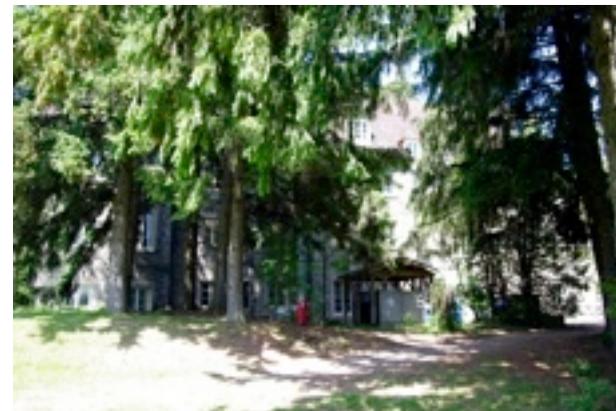
.31, .32, .33 (left)

Views of Eaton Hall; the west elevation, the entrance approach and former garage and the east elevation obscured by a copse of evergreen trees.

Should any addition(s) be required, it should not dominate the site or any of the primary vistas from or views to the Hall. This suggests that the primary candidate for an addition could be the east side of the house. The scale of an addition should be kept low, possibly no more than 2 stories and of a sympathetic design with related materials and a low key modern design. Any addition should not detract from a full 3 dimension understanding of the original house and any linkage should be light and ideally transparent.

Should any future addition be required we would recommend it be placed to the east side and the trees be thinned to create the necessary building site.

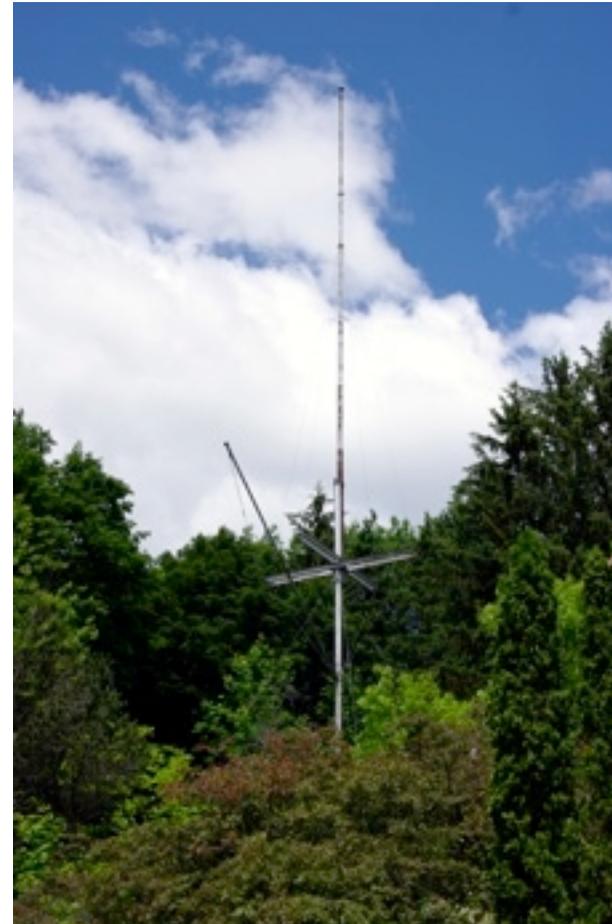
This unusual flag “pole” is designed in the form of a ships mast. This design only makes sense when the history of the use of the Hall during the Second World War is considered. During the war years the Hall was used as a recuperation hospital for the Navy and based on design and apparent age, it is very likely that this mast was erected at that time for that purpose.

.34 Mast-Flag Pole. This unusual flag pole is located on the north side of the entrance court. It is designed as a ships mast which can be understood when it is remembered that the Hall was used as a recuperation hospital for the Navy during WW2.

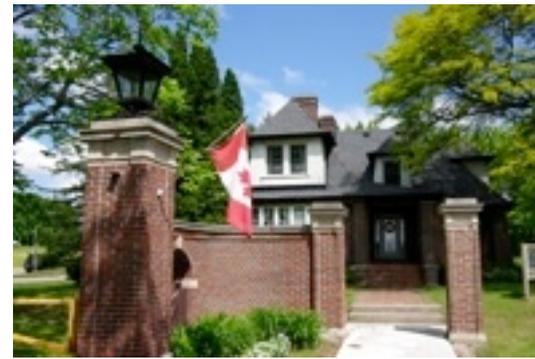
.37, .38 Entrance gate wing wall and gateway to the house. Note the man door gateway detail.

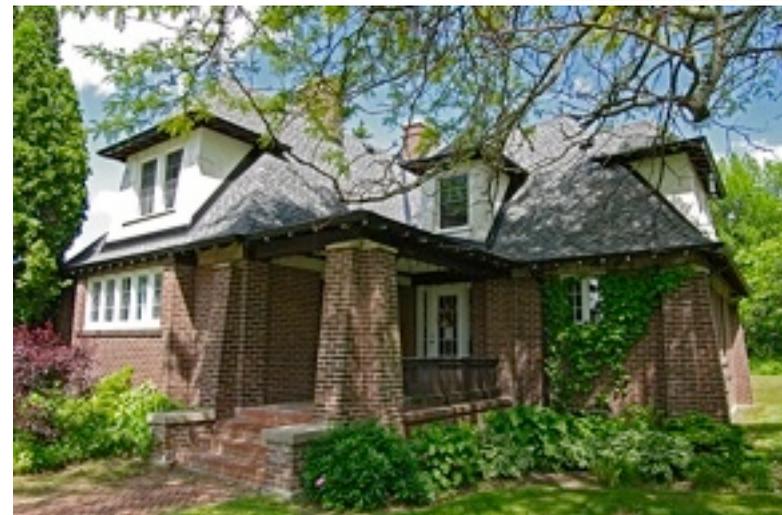
.39 View of gate house from the SE. The entrance porch and doorway are in alignment with the gate posts in the wing wall pictured above. It is a charming and picturesque Arts and Crafts design.

Any work planned for the building, or alterations for other uses, should respect the Arts and Crafts Style, heritage attributes and as much as possible retain original design elements on the prime elevations. Alterations on or to the rear of the building would be recommended and the interior could be altered for new uses.

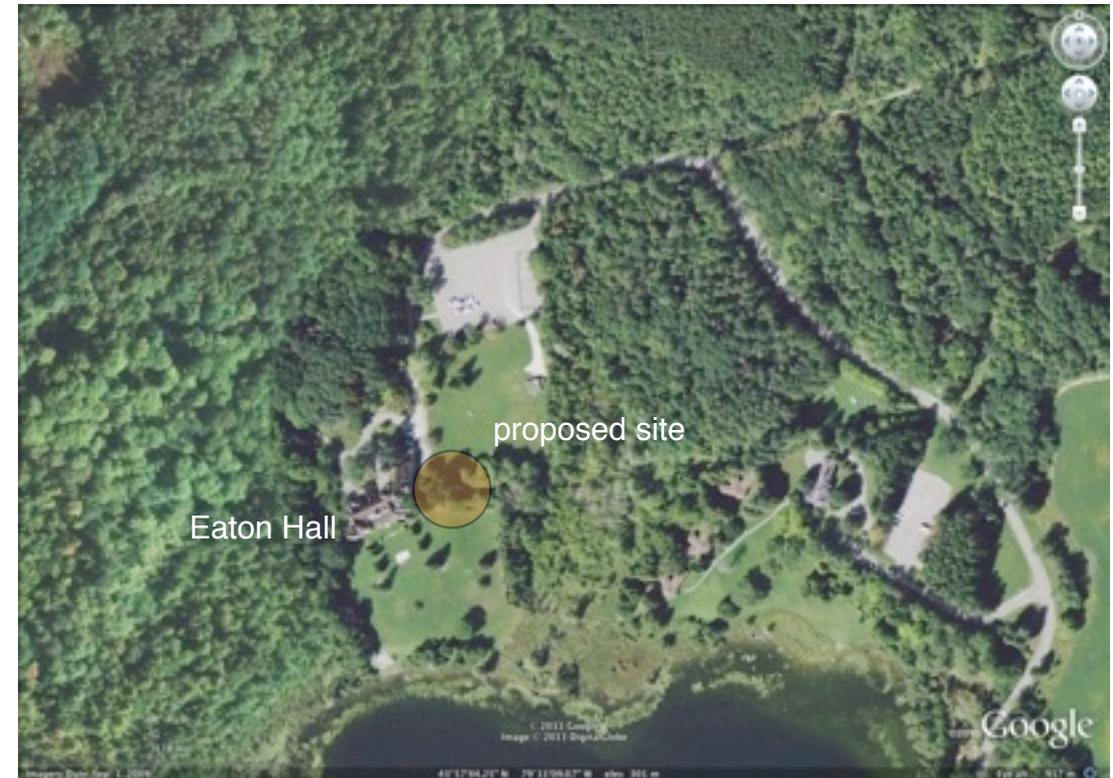
Site Location Plan, GE image

A review of the site and the relationship of the building to it, views from and to the building, site circulation and the layout of garden and lawns suggests there is a potential building site to the east side, the service side, of the house. A building wing could be located here which fits well into the landscape, does not dominate or affect views of Eaton Hall and could link to the Hall in an area of the floor plan that can best accommodate the link without disruption to important interior spaces.

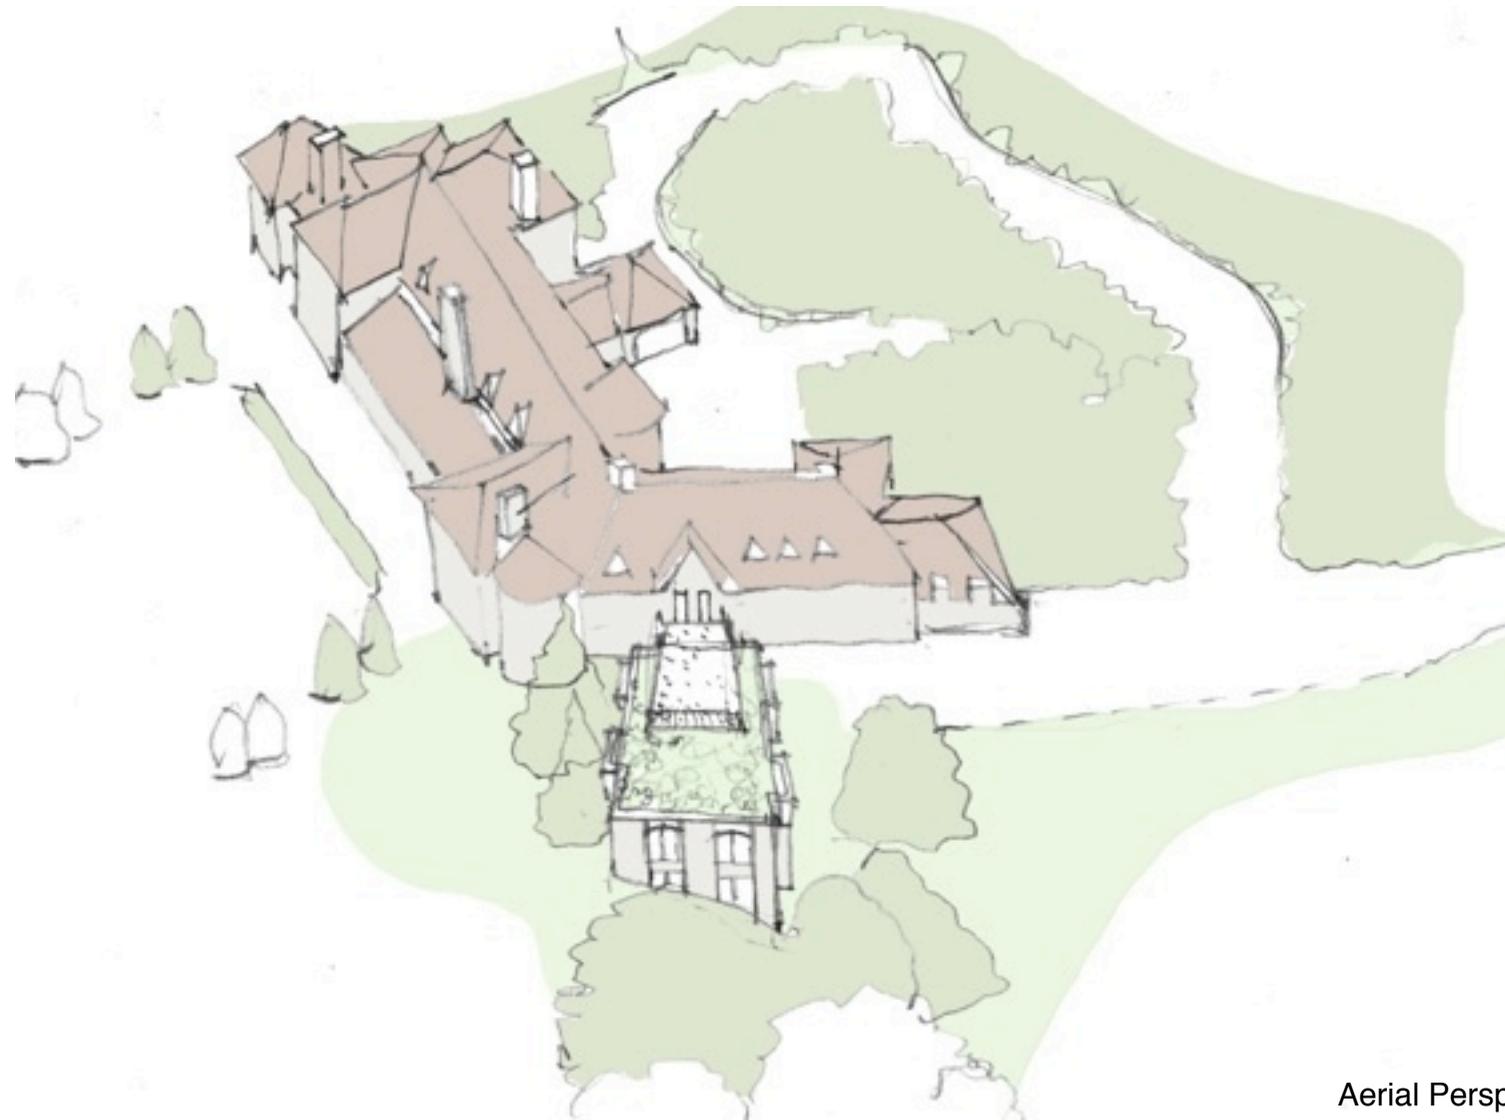
Aerial Perspective Sketch

The following sketches illustrate the concept.
